他廠 6HP 變速箱翻修不良圖示說明

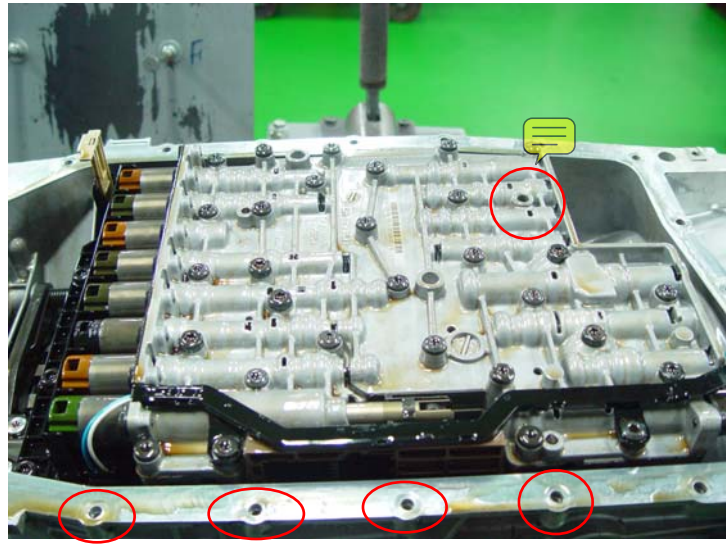
由於未按扭力磅數鎖油底殼，導致外殼鎖螺絲處凹陷不平，如此易導致油底殼變形漏油(油底殼材質為朔料材質)。  
閥體螺絲少鎖一個

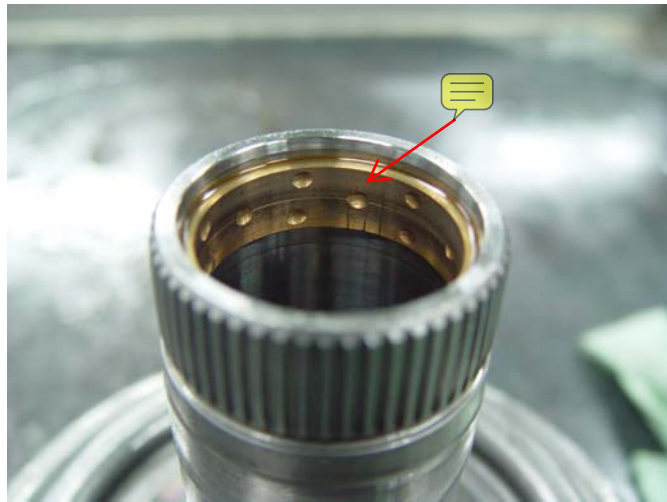
軸頸銅套鑽孔，誇張。

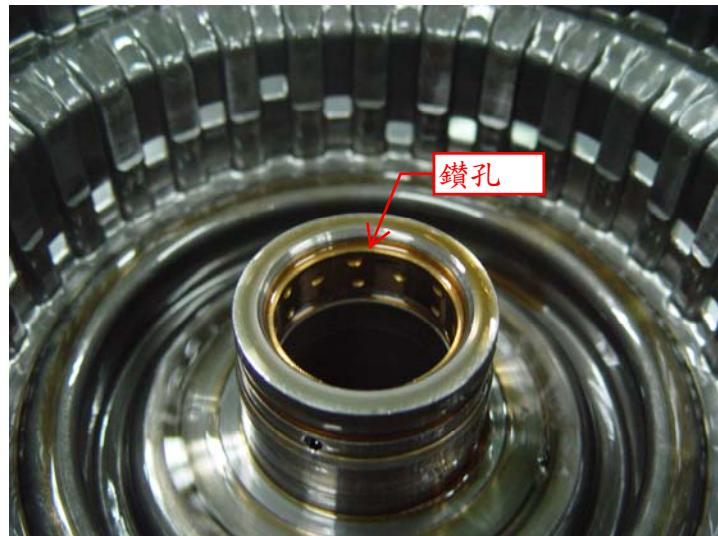
B 組缸體軸頸銅套上鑽孔，非正規做法，且無技術依據，為土法煉鋼，變速箱品質毫無保障，有損客戶權益。

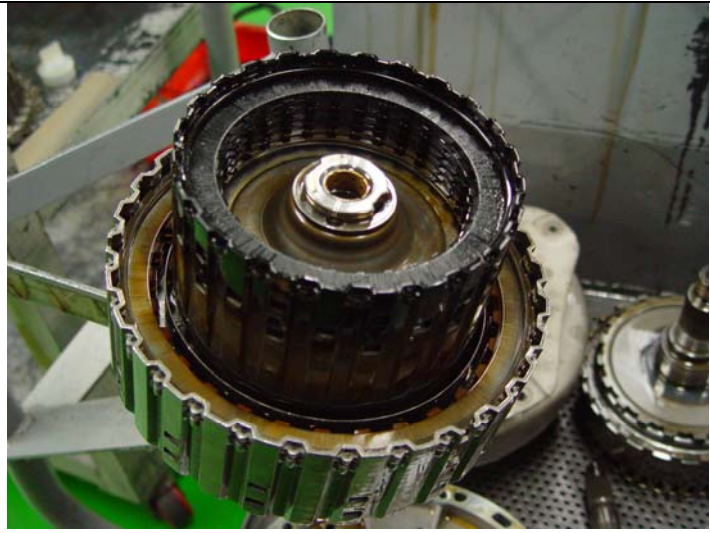
由於組裝品質不良，加上電腦閥體裝錯，導致內部燒毀嚴重。
